When a Long-Acting Contraceptive Device in the Uterus Is Not an “IUD”

William W. Brown III, MD

CASE

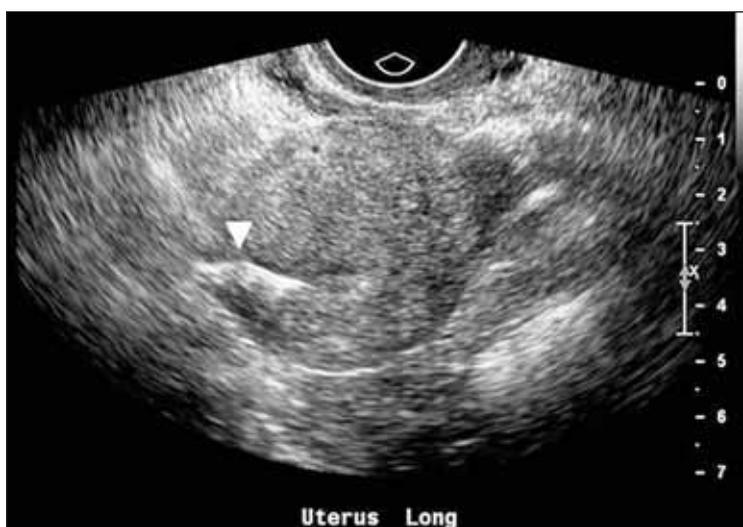
FIGURE 1A. Left sagittal view of the uterus. There is an undulating, bright, linear echodensity (arrowhead) high in the left cornu of the uterus. It appears to extend from the upper reaches of the endometrial cavity, through the myometrium and beyond the serosa.

When the IUD strings were not visible on pelvic examination, a pelvic ultrasound was ordered that showed an unrecognized foreign body in the uterus (Figures 1A, 1B). It lay eccentrically high in the left cornu and was suspicious for partial serosal perforation, so a referral was made to the gynecology service.

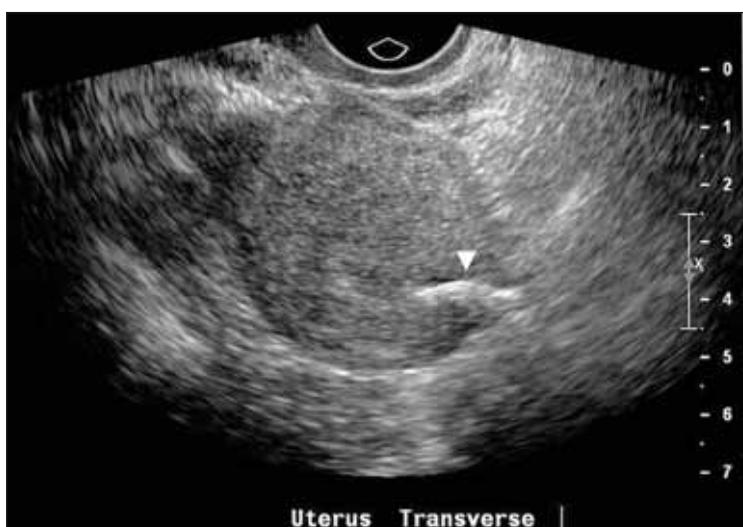
FIGURE 1B. The same device (arrowhead) is apparent when vaginal transducer is turned horizontally, although the endometrial cavity is less well defined. The remainder of the uterus is normal, with no evidence of other foreign bodies.

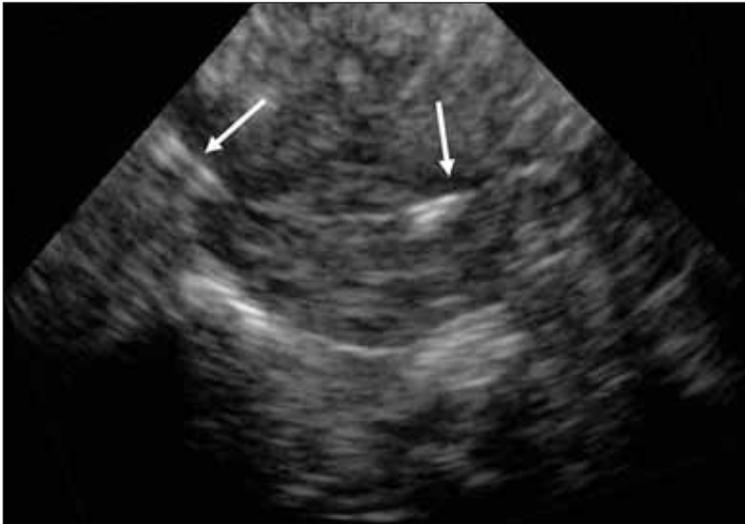
FIGURE 2. Multiplanar reconstructed (MPR) horizontal image, uterus. Two microinserts (arrows) are clearly evident, although the right has only minimal extension into the intramural fallopian tube. Double lines representing the device outer coil can now be appreciated.

Review of the previous ultrasound information uncovered a saved, unstudied 3-dimensional volume data set. Multiplanar reconstructed images confirmed bilateral implants (Figure 2), although the tubal mi-

The appearance on ultrasound of bilateral Essure microinserts after ideal placement has been well described²: A curvilinear echodensity is symmetrically located in each uterine cornu; the unwound outer coil of the device, made of nickel and titanium, looks like 2 parallel interrupted lines (Figure 2) with the proximal ends near to or penetrating through the endometrial-myometrial junction; rarely, a third singular echogenic line can be seen that represents the wound-down inner stainless steel coil.³

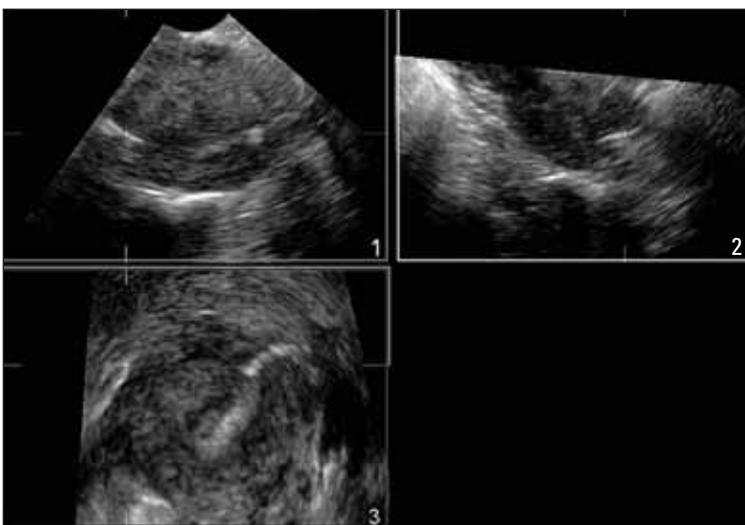
FIGURE 3. Complete MPR views showing the right-sided contraceptive device in each of 3 orthogonal planes (crosshair caliper). Box 1, transverse; box 2, sagittal; box 3, true coronal.

microinsert device on the right was located more distally in the fallopian tube than that on the left (Figure 3).
